Inadvertent insertion of a venous catheter into the internal thoracic vein: a word of caution

Central venous catheters are widely used in clinical practice and are linked to many types of complications, including incorrect positioning at the time the catheter is fitted. Here, the authors describe a case in which a fully implantable catheter was inadvertently positioned in the right internal thoracic vein. The complication was identified when the nursing team attempted to use the catheter. The right internal thoracic vein is within the radiographic projection of the right brachiocephalic vein and the superior vena cava, simulating correct catheter placement on an anteroposterior radiograph. In cases of central catheter malfunction during the immediate postoperative period, work-up should include oblique and lateral views, to rule out the complication described here without a need for computed tomography.

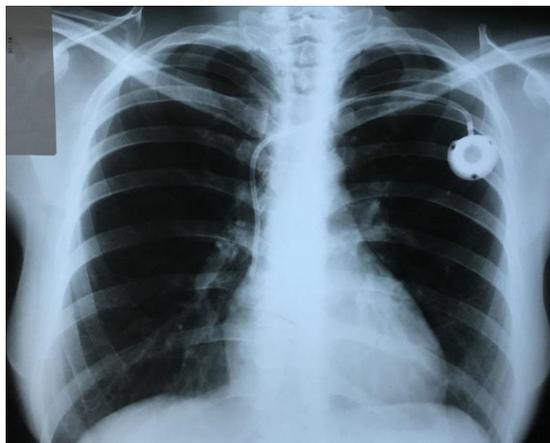
Figure 1. Anteroposterior chest radiograph taken in the immediate postoperative period, showing unremarkable positioning of the catheter.

A 49-year-old woman was admitted to our hospital for chemotherapy treatment of a right breast adenocarcinoma. She was scheduled for insertion of a long-stay central venous catheter. She had no previous history of central catheter insertion. On examination, no abnormalities of the neck or veins were found. A 9-French totally implanted catheter was inserted through the left subclavian vein under local anesthesia and sedation, under fluoroscopy, with adequate retrograde flow through the sheath and without any adverse events. Her anteroposterior chest radiograph showed the catheter in the desired position, without pneumothorax (Figure 1).

Inadvertent insertion of a venous catheter into the right internal thoracic vein can be quite easily overlooked during insertion, due to the apparent normal positioning in anteroposterior fluoroscopic view.⁷ The right internal thoracic vein is a tributary of the right innominate vein.⁴ It travels adjacent to the right internal thoracic artery on the posterior face of the anterior chest wall. This path means that the right internal thoracic vein overlies the superior vena cava in anteroposterior projections, so it looks normal in radiographs and fluoroscopy. On the other hand, this kind of malpositioning is easily recognized if lateral or oblique views are used.⁷ The patient in this report didn't have lateral or oblique imaging, because the anteroposterior in-room fluoroscopy was normal. The vascular surgical team opted for computed tomography instead of a lateral chest radiograph mainly because this complication did not occur to them and to search for other possible causes of thoracic pain. Notwithstanding, computed tomography scanning can show more precisely whether or not the catheter is in an intravascular position in case of malposition, when compared to lateral chest radiography.¹

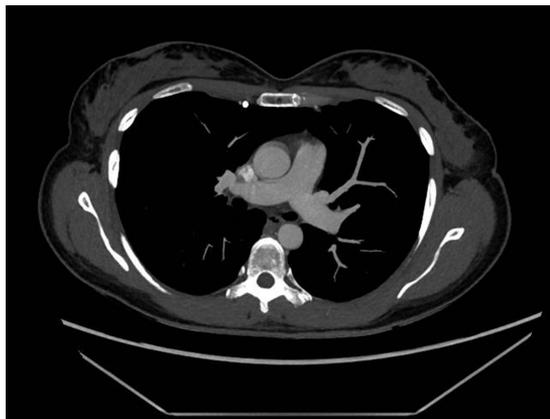
Figure 2. Axial computed tomography image showing the port-a-cath positioned behind the anterior chest wall.

Two days later, our vascular surgery team was called because of catheter malfunction, with difficulty and pain during administration of medication. Her chest radiograph was normal, but due to persistent malfunction and pain, a chest computed tomography was performed. It showed malpositioning of the catheter, with the distal portion inserted into the right internal thoracic vein (Figures 2 and 3).

The patient was taken to the operating room once more and the catheter was exchanged without any adverse events. Contrast was injected through the catheter, confirming flow into the superior vena cava. The patient recovered uneventfully from the procedure, and was discharged home to proceed with ambulatory chemotherapy. The patient gave consent for publication of this case report.

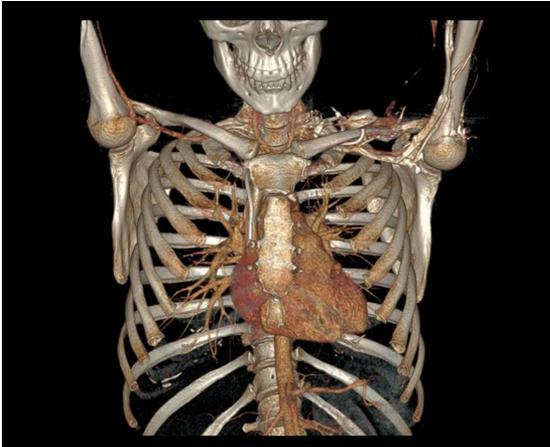
Figure 3. Three-dimensional computed tomography reconstruction also showing the catheter positioned in the right internal thoracic vein.
